REMEDIAL ACTION COMPLETION REPORT FOR SITE 3 SUPPLY SIDE LANDFILL NSTC  
GREAT LAKES IL  
12/1/2009  
TETRA TECH

Remedial Action  
Completion Report  
for  
Site 3 - Supply Side Landfill

Naval Station Great Lakes  
Great Lakes, Illinois

CONTRACT NUMBER N62467-04-D-0055  
Contract Task Order 512

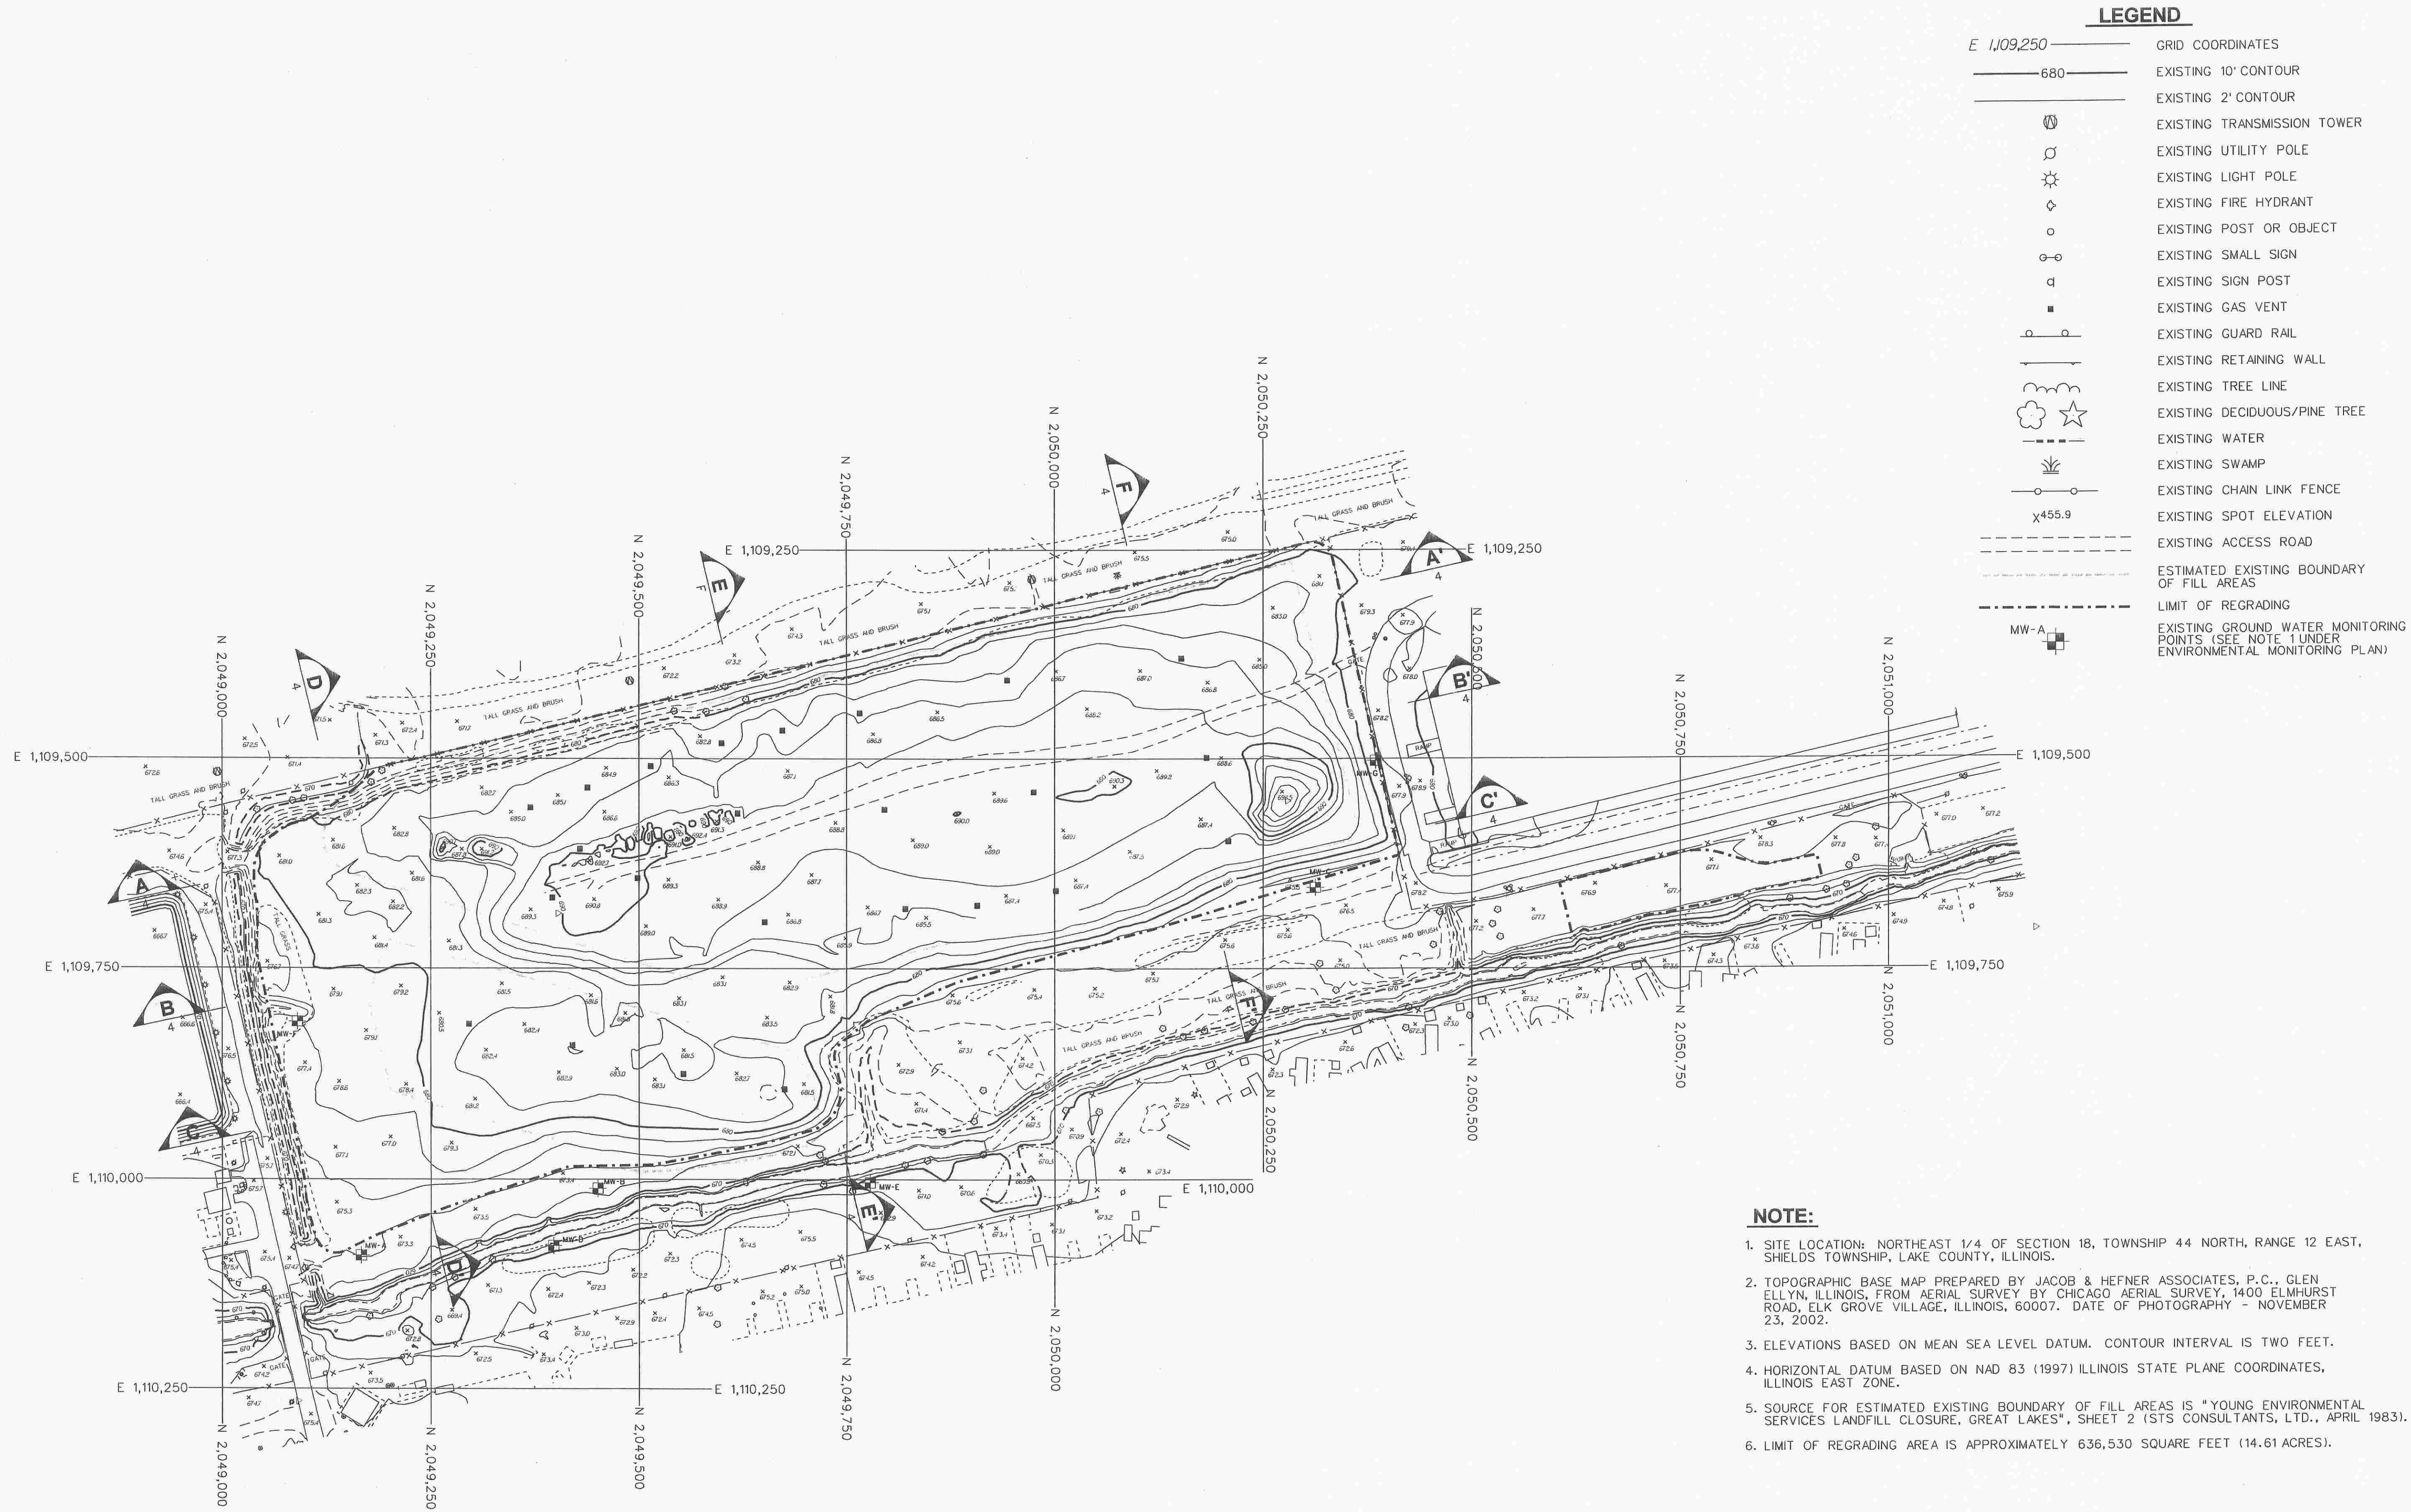
### **PRE-CONSTRUCTION SITE MAP**

DRN PAA PAA	8-13-2003	DES PAA PAA	8-13-2003	CHK CR	8-13-2003	APP A/D	8-13-2003
<b>Vernal inc.</b> 200 W. 22nd STREET, SUITE 250 LOWEARD, IL 60148							
EXISTING CONDITIONS INVESTIGATION AND PROPOSED MODIFICATIONS TO LANDFILL COVER SYSTEM SUPPLY SIDE LANDFILL NAVAL STATION GREAT LAKES							
DATE AUGUST PROJECT NO

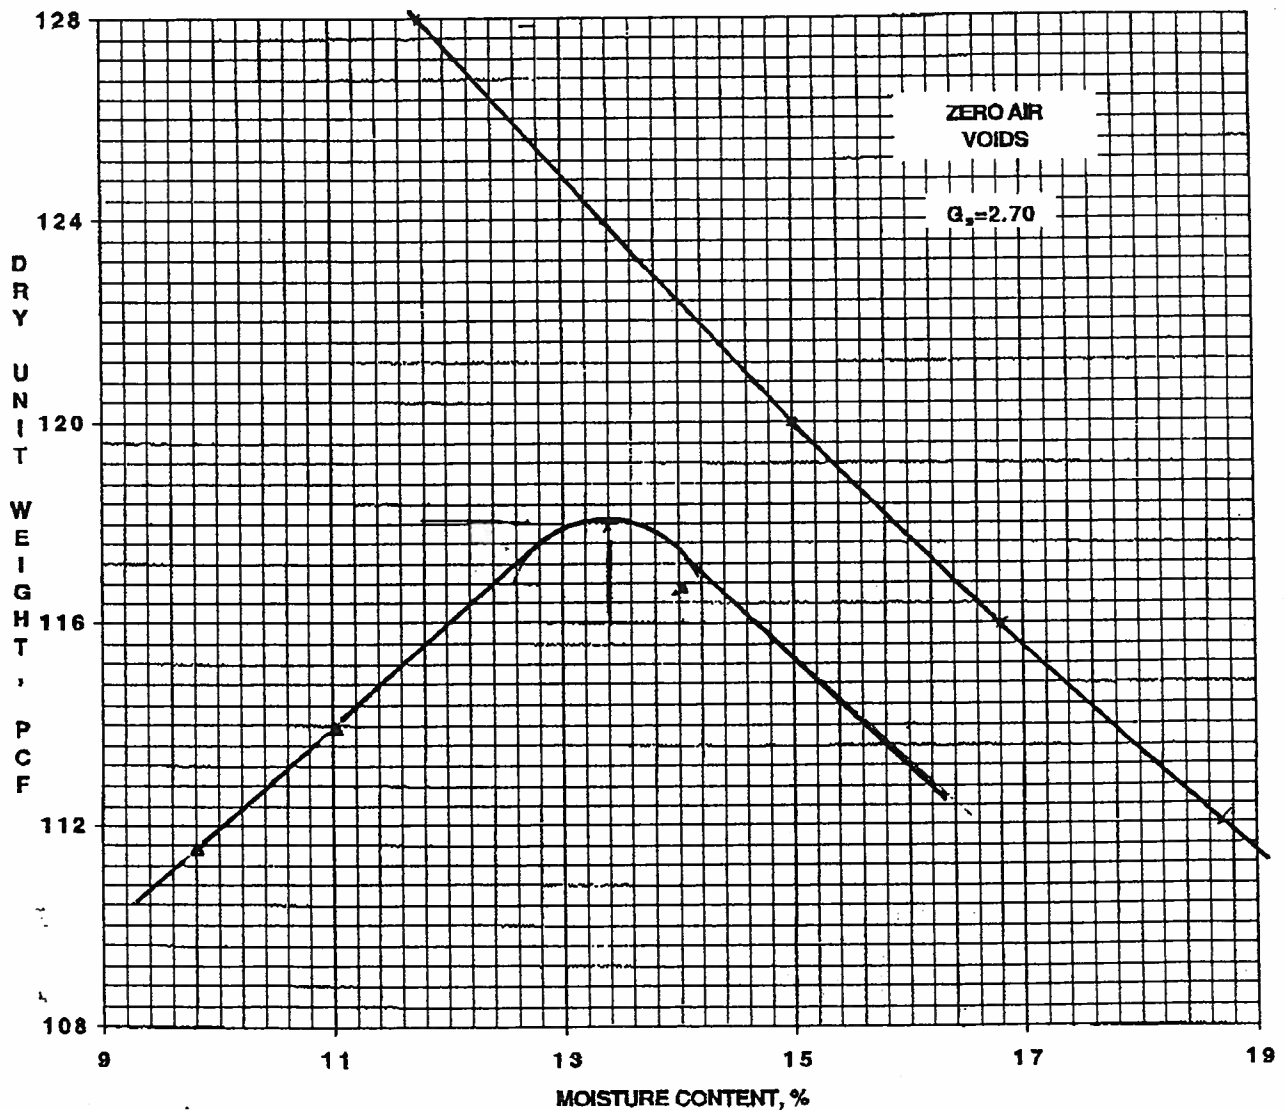
REPORT NO. 4 MDR  
DATE: 6/4/04  
OUR JOB NO. 74275

DESCRIPTION OF SOIL: Brown and grey Silty CLAY, Little Sand, Trace Gravel, CL RAMMER TYPE: MECHANICAL  
TEST PROCEDURE: ASTM D 698 PREPARATION METHOD: DRY  
MATERIAL SOURCE: Stockpile #4 MOISTURE CONTENT AS RECEIVED: 14.0%  
TEST RESULTS: MAXIMUM DRY DENSITY 118.0 PCF OPTIMUM MOISTURE 13.4%

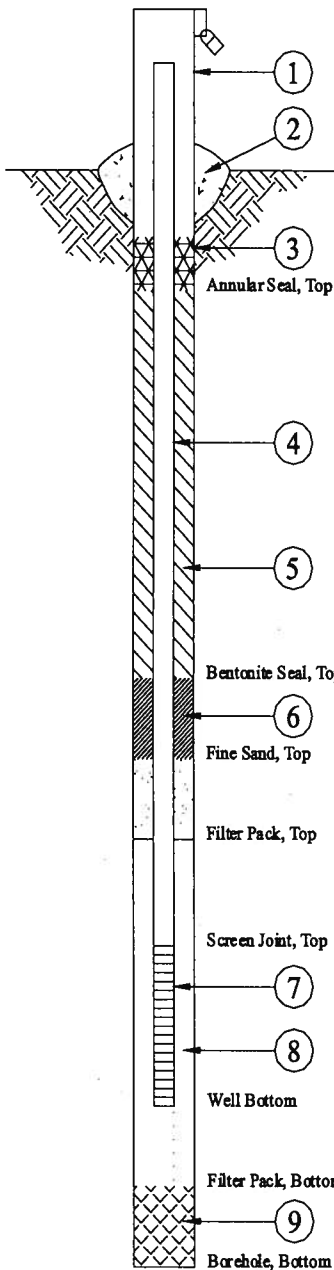
Depth (ft) 2

Elev. 678.02

Depth (ft) 6

Elev. 674.02

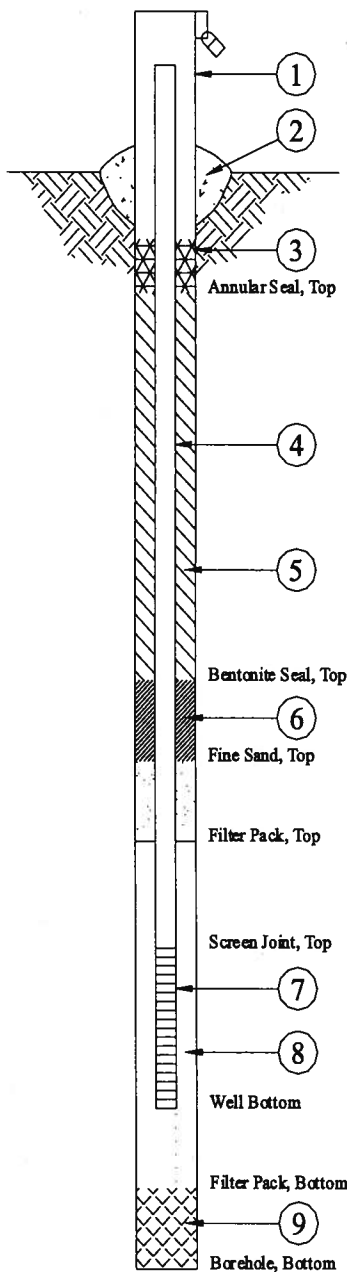
Ground Elev. 677.47

Depth (ft) 2  
Elev. 675.47

Depth (ft) 6  
Elev. 671.47  
Depth (ft) N/A  
Elev.

Depth (ft) 8  
Elev. 669.47

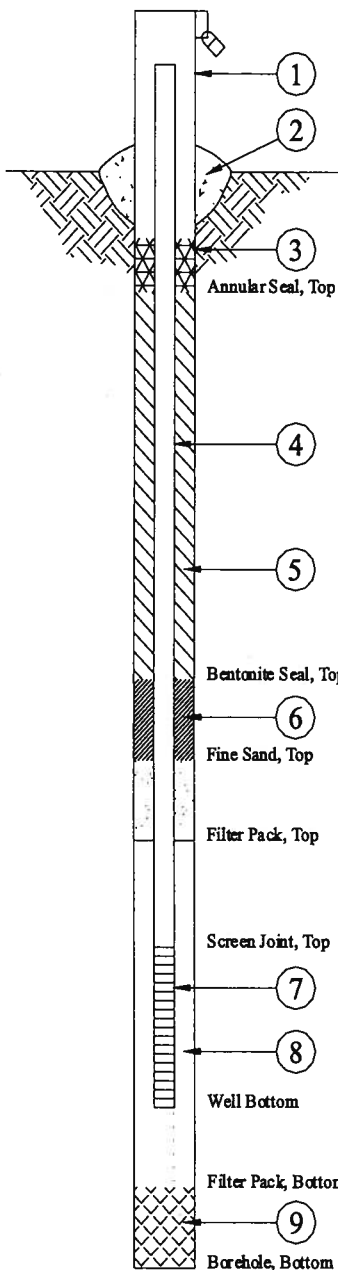
Depth (ft) 2

Elev. 673.83

Depth (ft) 6

Elev. 669.83

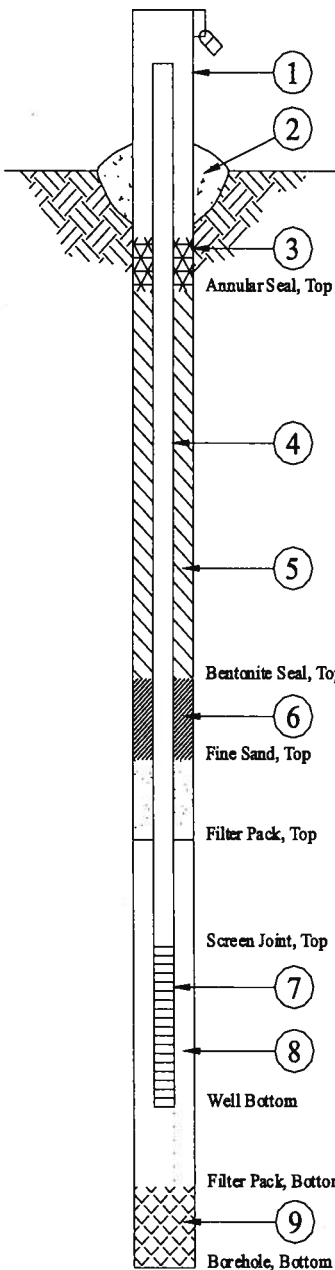
Depth (ft) 2

Elev. 670.07

Depth (ft) 6

Elev. 666.07

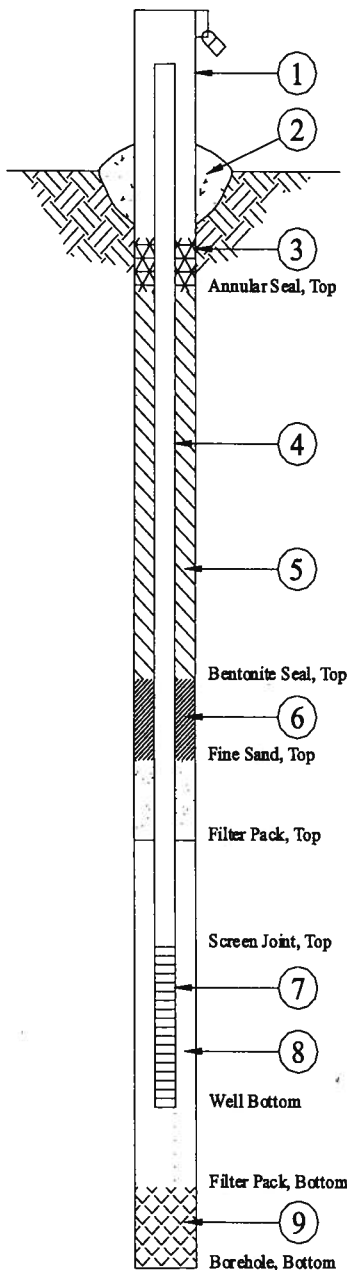
Ground Elev. 673.88

Depth (ft) 2  
Elev. 671.88

Depth (ft) 6  
Elev. 667.88  
Depth (ft) N/A  
Elev.

Depth (ft) 8  
Elev. 665.88

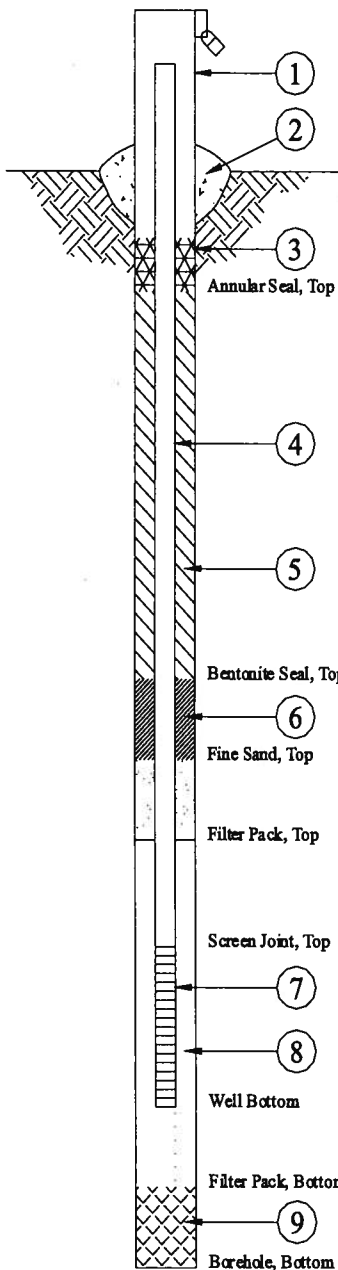
Ground Elev. 676.15

Depth (ft) 2  
Elev. 674.15

Depth (ft) 6  
Elev. 670.15  
Depth (ft) N/A  
Elev.

Depth (ft) 8  
Elev. 668.15
